### **Submitted by:**

Thomas D. Durbin
Kent C. Johnson
Jiacheng Yang
Yu Jiang
University of California
CE-CERT
Riverside, CA 92521
951-781-5791
951-781-5790 (fax)

#### **Executive Summary**

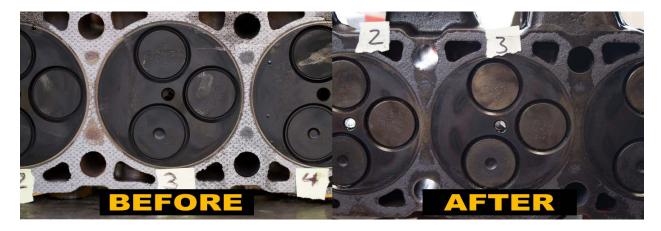
Figure 3-1. Before and After Pictures of Intake and Exhaust Valves.

- A noticeable cleaning effect was found in comparing picture of the engine disassembled before and after the mileage accumulation. This cleaning is most readily seen for the valves, where there is a considerable reduction in the build of black carbon on the heads after the conclusion of the mileage accumulation.
- There was also a reduction in the amount of the black carbon build up on the piston heads, although this is a bit difficult to see simply from pictures. This reduction in black carbon buildup was primarily seem in the groove on the piston head.
- The valve stems and fuel injectors did not show a significant cleaning affect.

The engine was disassembled before and after the mileage accumulation with the Biofriendly additive. Figure 3-1 to Figure 3-4 show pictures of the intake and exhaust valves, combustion cylinders and piston heads, fuel injectors, and valve stems, respectively. To allow for a better comparison of the condition of the engine before and after the mileage accumulation, the before and after pictures are presented side by side. Overall, the pictures show a noticable cleaning effect between the before and after mileage accumulation photographs. This cleaning is most readily seen in the pictures of valves in Figure 3-1, where there is a considerable reduction in the build of black carbon on the heads after the conclusion of the mileage accumulation. There was also a reduction in the amount of the black carbon build up on the piston heads, although this is a bit difficult to see simply from pictures. This reduction in black carbon buildup was primarily seem in the groove on the piston head. For the valve stems, there was not a significant reduction of black carbon, although some valve did appear to also show a reduction in the black carbon build up. The fuel injectors did not show a dramatic reduction in black carbon between the before and after pictures. It should be noted that the reduction in black carbon was also noted by one of the main technicians

servicing the engine. He noted that the change in the engine condition and the observed cleaning was significant, and that the condition of the engine appeared to be consistent with hotter combustion.
