Letter of No Objection for fuel additive Green Plus Combustion Catalyst

REPORT			
Name of Vessel:	MAERSK ARUN	IMO No:	9175779
Name of Yard:	China Shipbuilding Corp.	Hull No:	678
Engine Type:	7S50MC	Sea Trial:	199 03 01
Visit by:	GSM 2300	Service Center:	Copenhagen
Engine Builder:	HITACHI	Engine No:	3776
Order No:	40 003 320	Run. hours:	32906
Place:	Varna, Bulgarian		
Period:	2005 09 17		
Owner:	The Maersk Company Co Ltd		
Requested by:	Biofriendly Corp.		
Reason:	Inspection after running with Green Plus fuel Additive		
Keywords:

M/V MAERSK ARUN 7S50MC IMO 9175779
Varna, Bulgarien 2005 09 17

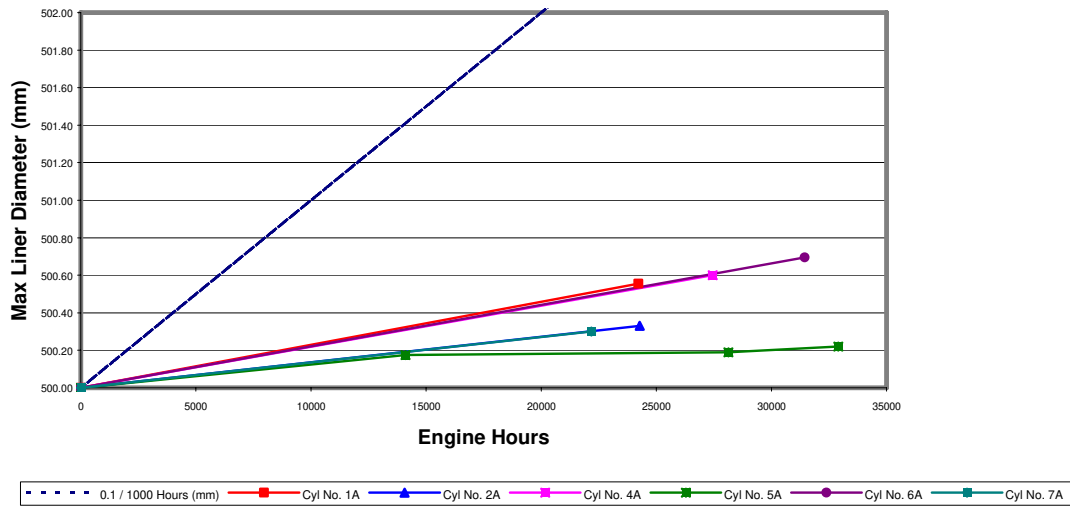
Max. Liner Diameter Analysis
MAERSK ARUN HITACH-003776

The liner was in good condition with no machining marks visible. The max. wear was found at top of liner in ring 2, top dead centre and was 0.22 mm, i. e. 0.007 mm/1000h from new and the same as since last overhaul, as seen below.. Wear edge at ring 1 in TDC was ground away.

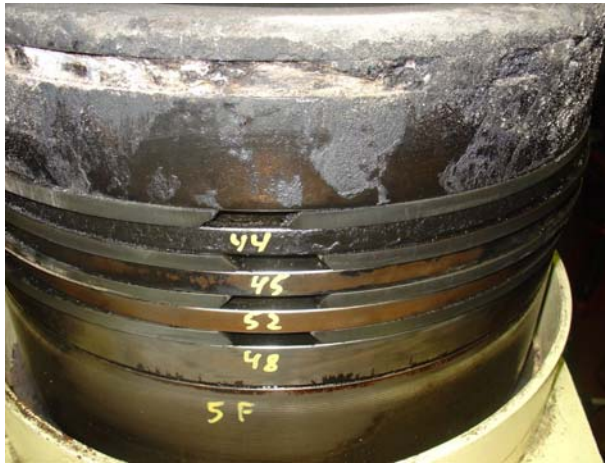
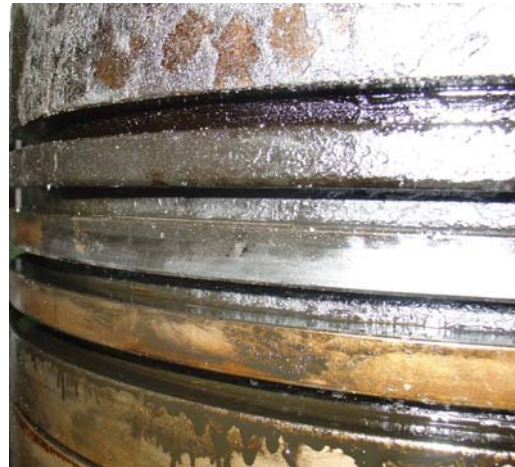
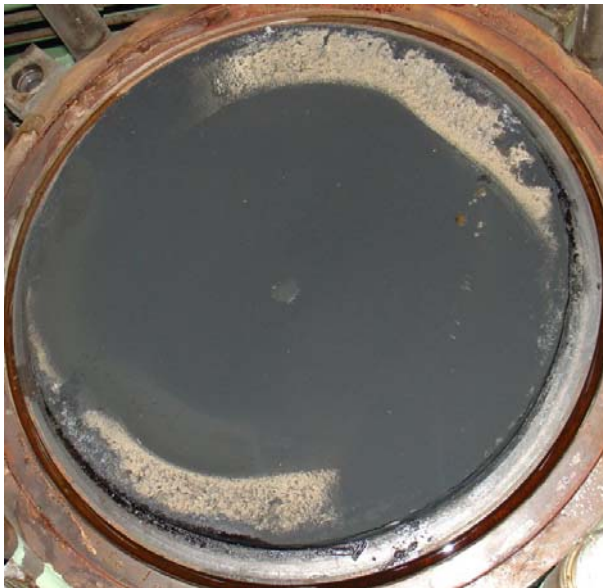
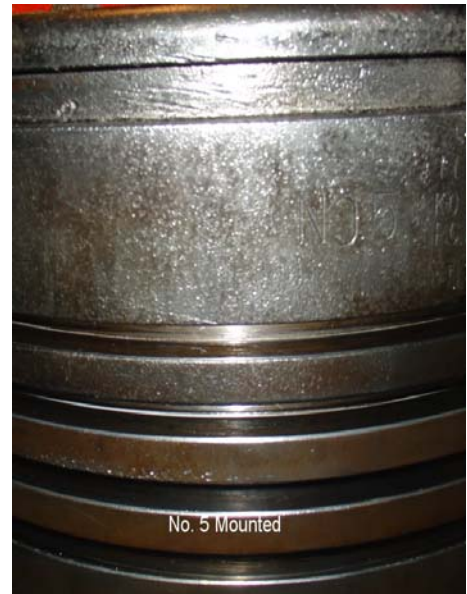
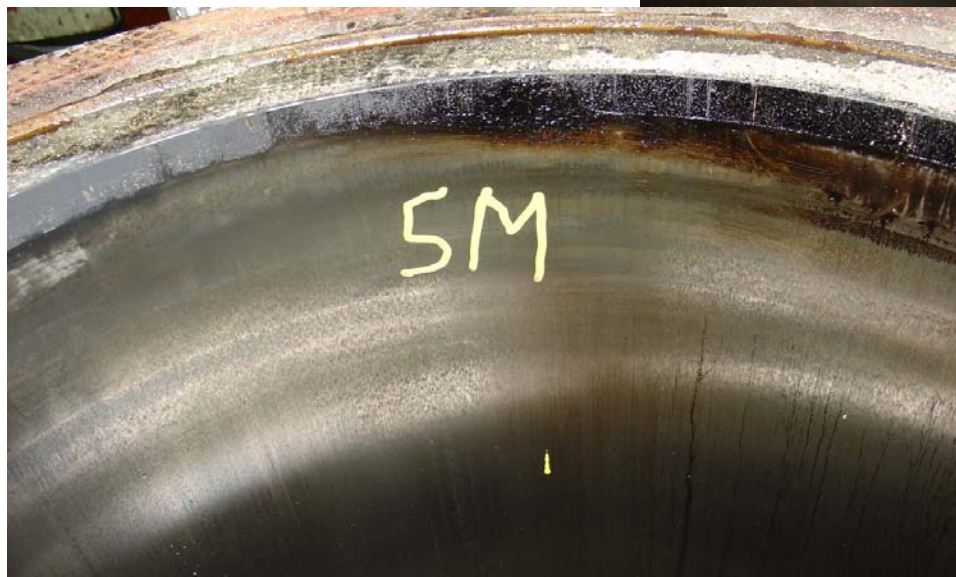
The piston was in good condition with medium carbon on topland and light carbon on ringland 1. There was a yellow layer of deposit on top of the piston top, but less than at last inspection. All piston rings were in good condition with only small reduction in the tension. The max. piston ring wear was for ring No. 1 and was 1 mm, i. e. 0.2 mm/1000h. There was only small amount of deposit at the back of the rings and a thin layer at the bottom of the ring, grooves No. 1 and 2. There is only little wear for the ring grooves and no burning of piston. Piston skirt without bronze band in good condition. Spare piston was fitted with Daros RM5 Alu-coated top ring the other Riken 47

The Exhaust valve and Cylinder cover were in good condition.

The inspection from exhaust side shows good condition for all units as seen on the picture, all are more or less alike, but with different running hours as seen on page 4. All piston rings were in good condition and with shape as seen on page 4. All liners were with machining marks slightly visible in the inspected area, at manoeuvring side and the max. wear for all liners as seen below.
