### **Submitted by:**

Thomas D. Durbin
Kent C. Johnson
Jiacheng Yang
Yu Jiang
University of California
CE-CERT
Riverside, CA 92521
951-781-5791
951-781-5790 (fax)

#### **Executive Summary**

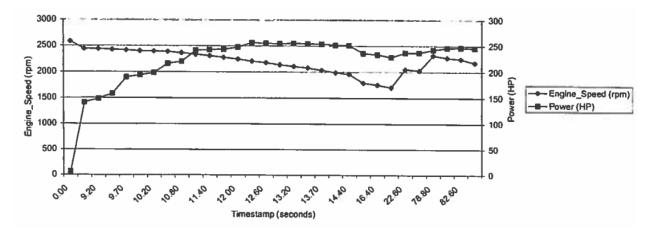
Figure 3-5. Before Mileage Accumulation Horsepower Test Results

Horsepower tests were conducted before and after the mileage accumulation with the Biofriendly Green Plus additive. These horsepower curves were run on the repair grade dynamometer at Johnson Machinery. Horsepower curves from before mileage accumulation are shown in Figure 3-5 and Figure 3-6. The horsepower curve for the after mileage accumulation is shown in Figure 3-7.
